Heathkit of the Month #93:
by Bob Eckweiler, AF6C

KIT RESTORATION

Heathkit CS-1

Condenser¹ Substitution Box.

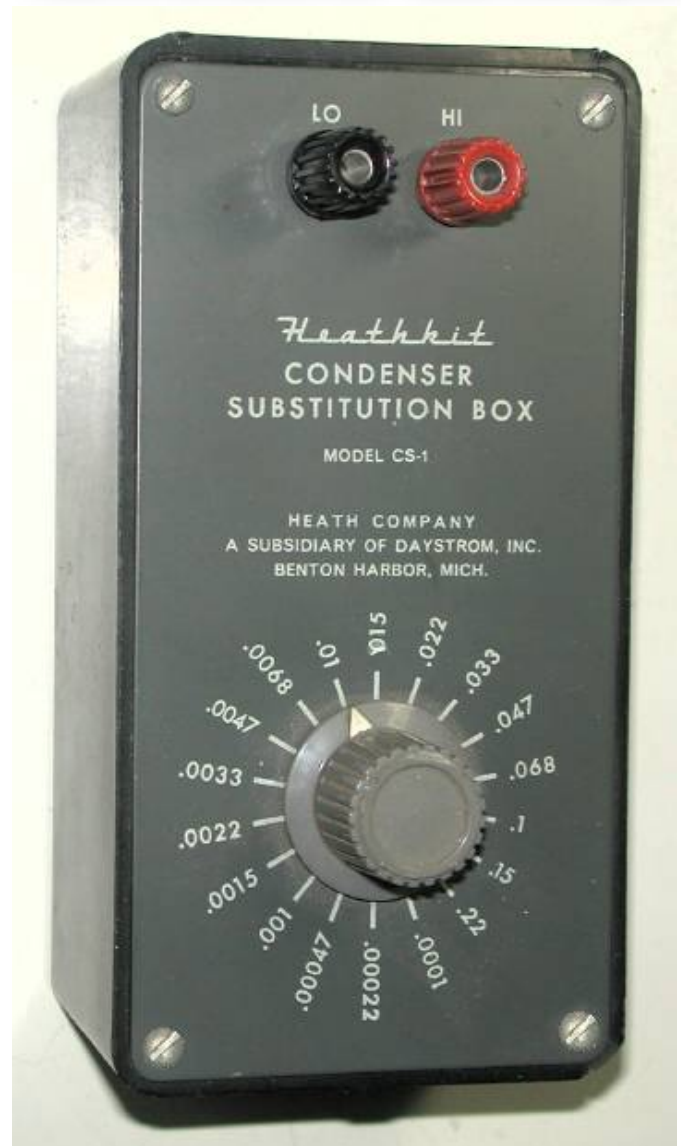
Figure 1: The Heathkit CS-1 prior to restoration

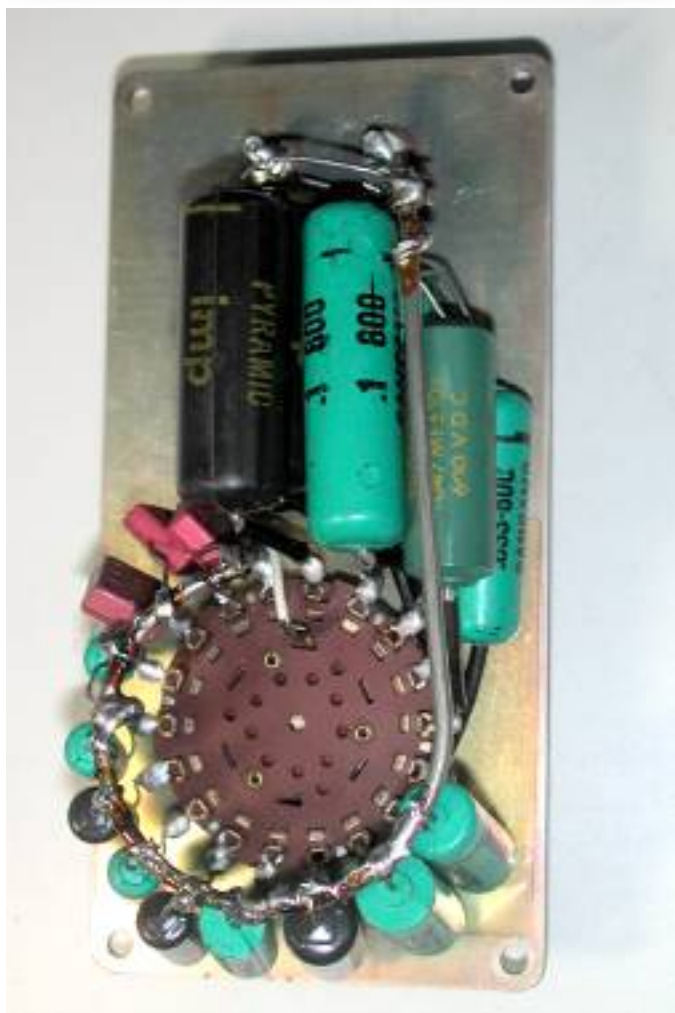
The original layout of the CS-1 was tight due to the large size of the original capacitors (See **Figure 3**). The twelve smallest capacitors (0.0001 μf to 0.022 μf) mount vertically from the switch to the curved part of the “condenser mounting unit”. The manual instructs that the leads be cut to the specified length and that the spacing between the top of the largest of these capacitors (0.022 μf) and the mounting unit be at most 1/8”. The remaining six capacitors are too large to

Figure 3: Internal view of the original CS-1.

mount vertically and mount horizontally with their common lead connecting either to the straight part of the mounting unit or the black terminal solder-lug.

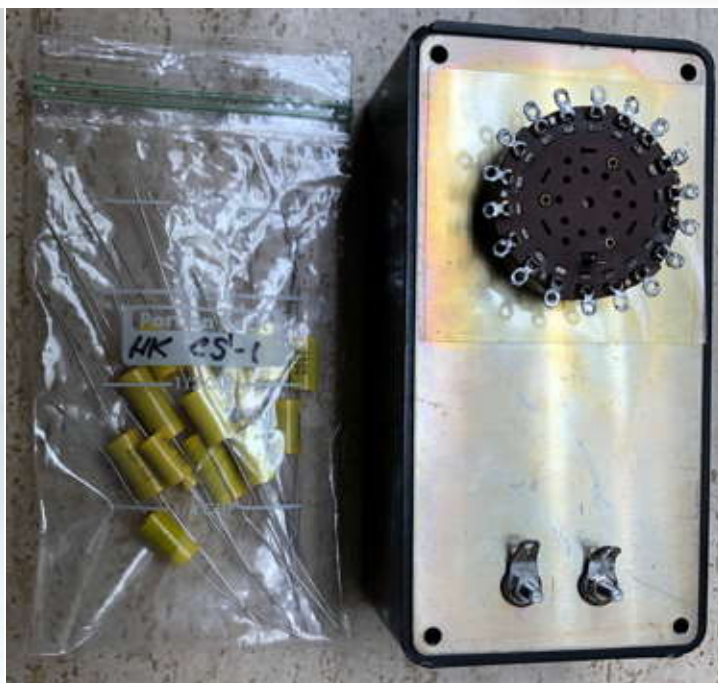
Reassembly begins with reinstalling the switch, plastic insulator and the two binding posts per the manual instructions. **Figure 4** is the partially assembled CS-1 awaiting the addition of the capacitors.

Figure 4: partial reassembled CS-1 awaiting capacitor installation
