Heathkit of the Month #125:
by Bob Eckweiler, AF6C

Heath IT-12 A (Quick) Refurbishment
Visual - Aural Signal Tracer

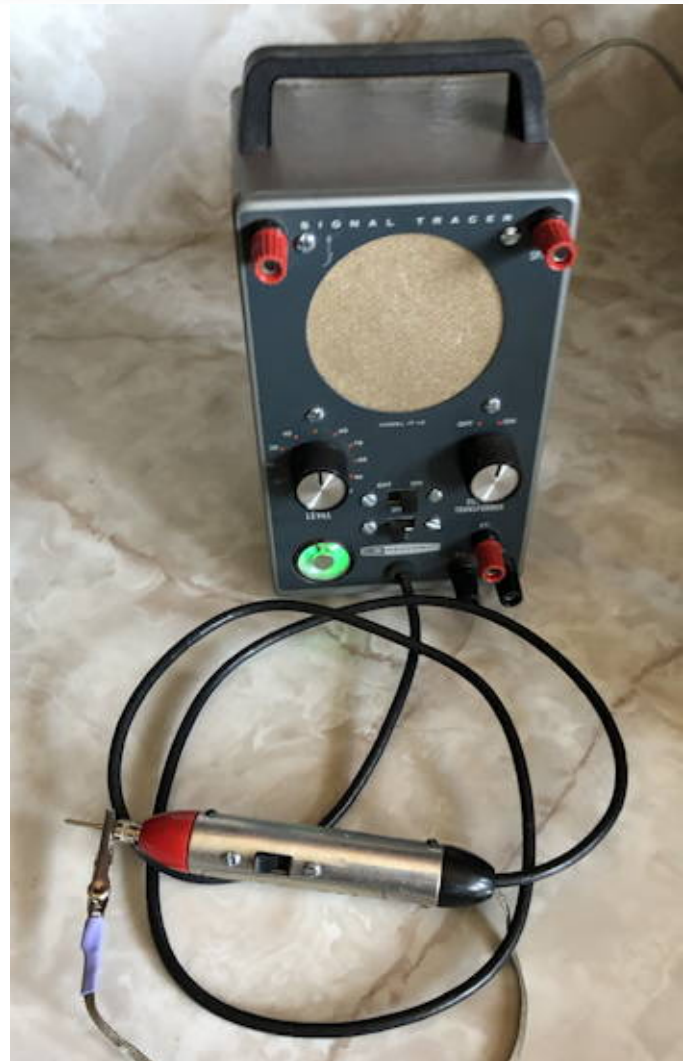
Figure 1: The refurbished IT-12 Showing the probe, bright 1629 eye-tube and later style knobs. The probe features an authentic #477-3 Solder less probe tip replacing the broken one on the unit as received.

IT-12; Series: 09545). One problem noticed was the tip was broken off the probe. These tips are used on numerous Heathkit probes and break easily. A few such probes are in-house awaiting a new tip which had, until while writing this article, no known source.

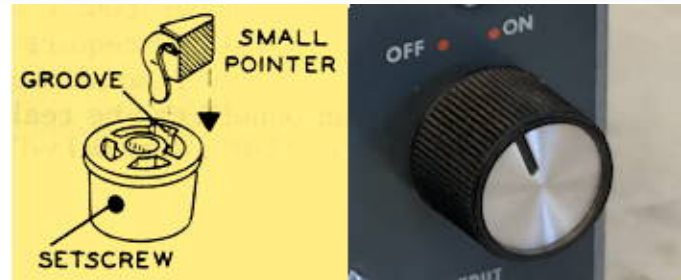
pointer while the later knobs just had a black line on the silver disc. (**Figure 3**). Other than that, they looked identical externally.

Figure 3: Left: a drawing shows the assembly of the knob (with setscrew in place) #462-139 and pointer #463-27 on early units. Right: Later units had a knob with a painted line #462-187 and no setscrew, which was supplied separately.

5. The two knobs were changed from a knob (#462-139) with attachable white pointer (#463-27) to a knob (#462-187) with a line instead of pointer. Setscrews came with the early knobs, but separate 8-32 x $\frac{1}{4}$ setscrews (#250-43) were provided for the later knobs.

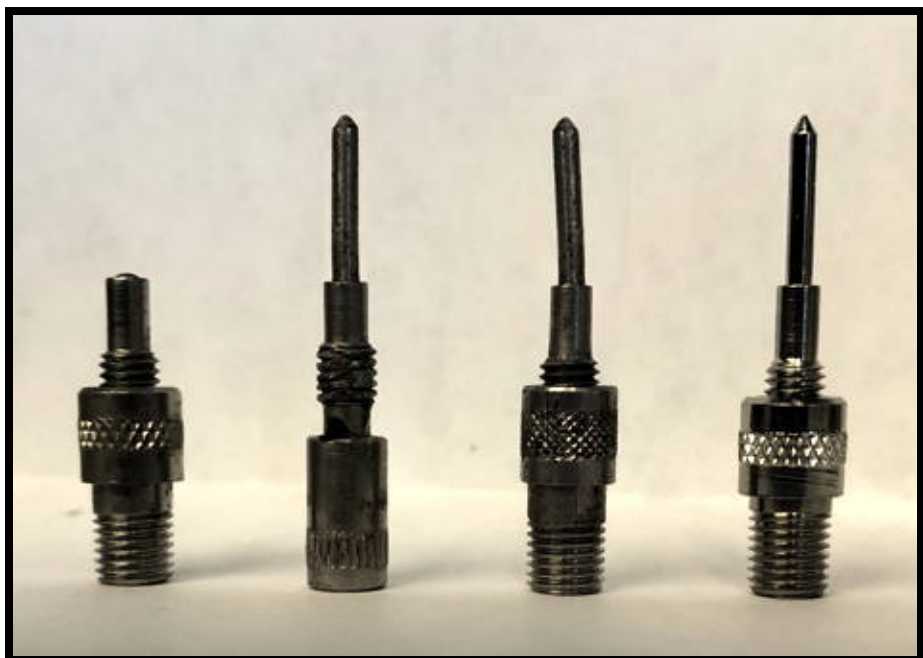
Figure 6: See Text

1. The broken IT-12 tip.
2. An equivalent tip that is press-fit instead of screw-in (one of the attempts at finding the correct probe tip). It is missing the knurled collar due to thread damage.
3. The bent tip originally from a Heath PK-3 probe.
4. The new H.H. Smith 124 probe tip.
