# RF

ORANGE COUNTY AMATEUR RADIO CLUB, INC.

July 2018

It seems like this project took forever to complete, though actual time working on it was not many hours over a long period. Part I appeared in the April 2018 issue of *RF* and covered “siliconizing the selenium rectifier” in the V-6. This amounts to removing the selenium plates and replacing them with a silicon diode (a 1N4004 here) while keeping the outside appearance of the original part. The restored Heathkit V-6 VTVM (circa 1952 to 1954) is shown in **Figures 1** and **2** during burn-in. **Figure 15** shows the V-6 schematic.

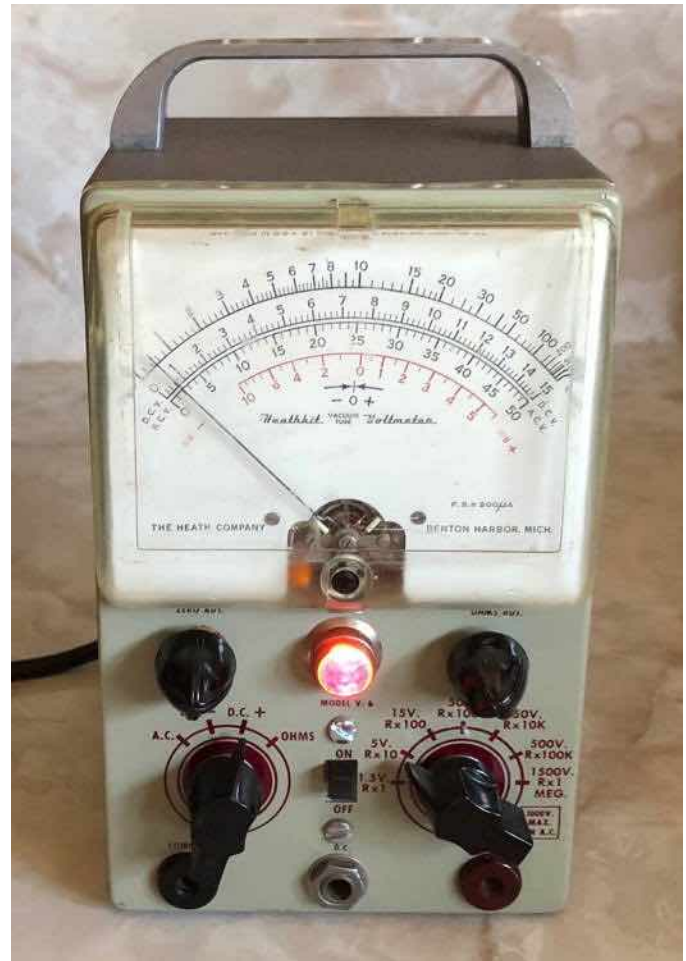
**Figure 1:** Completed restoration of the Heathkit V-6 VTVM during burn-in. The slight meter offset is intentional and indicates the circuit continues to function.

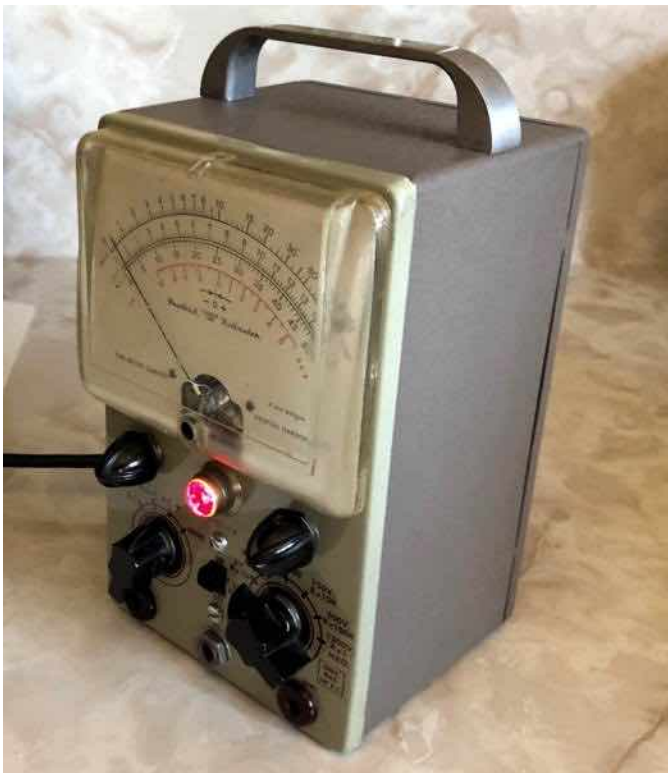
**Figure 2:** Another photo of the completed restoration of the Heathkit V-6 VTVM during burn-in. This photo shows the repainted case color.

The cabinet of the V-6 was generally in good shape. there were a few scratches on one side and the paint was faded and stained, even after a good cleaning. The V-6 is in the "Late Pre-Classic" style<sup>11</sup>. The case is painted a gray wrinkle and seems to have a hint of brown. Finding wrinkled paint, let alone paint to match, is a problem. A base paint of the proper texture has yet to be found. I ended up choosing to leave the original paint, with its wrinkle finish in place as a base coat and cover it with a new coat of satin paint. After much searching I found Rust-oleum 2X London Gray (shouldn't that be London Grey?) paint while perhaps a little on the brown side, once on it looked close to original.

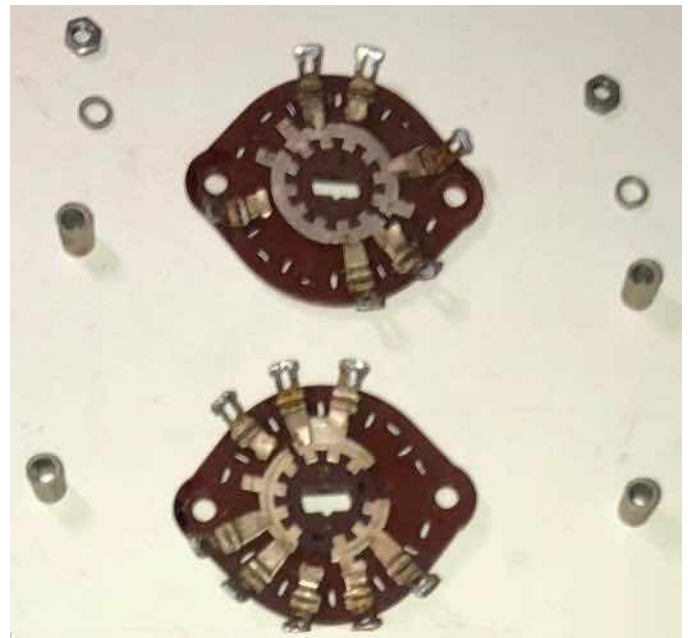
**Figure 4:** Disassembled function switch wafers awaiting cleaning.

enough apart so large precision resistors can be mounted from one deck to the other. In total, the switch holds fourteen precision resistors. Since they are easy to damage and hard to replace, there was no reason to remove them. The switch itself was cleaned and all resistors checked. One 200 K $\Omega$  precision resistor was obviously open as it was bypassed by two tiny 0.1 watt 100K precision resistors in series. These were removed, as was the dead original, and a 200K precision resistor was ordered from a parts warehouse (luckily it was a common value, unlike some of the others). The range switch had suffered some of the corrosion damage caused by the leaking battery. It manifested itself on the nut end of one of the long screws holding the wafers. The nut and an area of the screw around the nut were rusted. Instead of trying to unscrew it a rust converter<sup>5</sup> was used to neutralize the rust and prevent further damage.

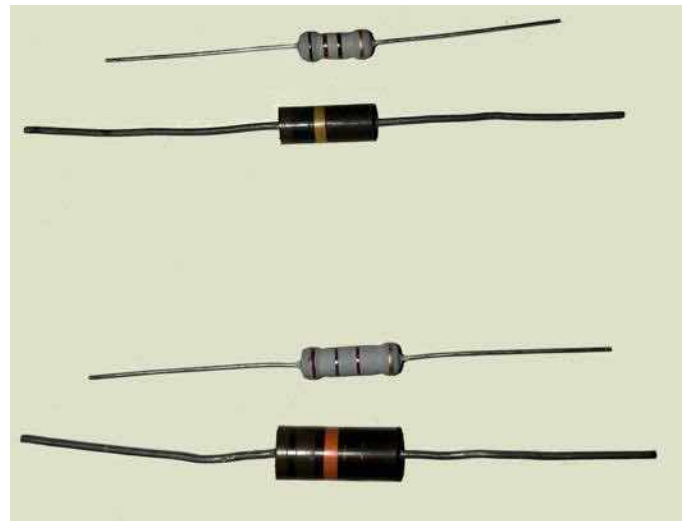
**Figure 5:** Resistor size comparison (from top to bottom):  
1-watt metal oxide, 1-watt carbon composition,  
2-watt metal oxide, 2-watt carbon composition.

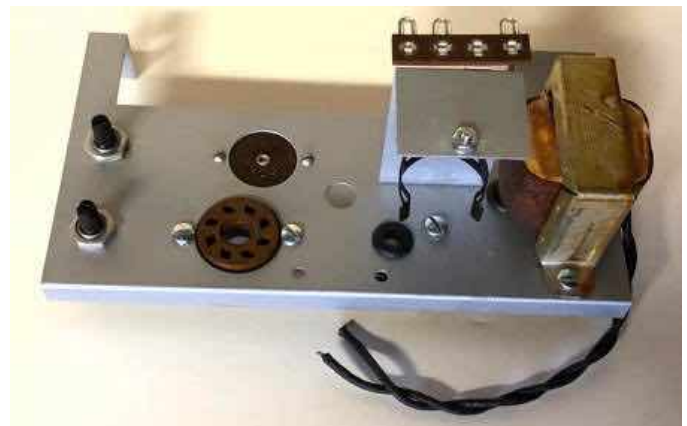
**Figure 6:** The V-6 chassis, cleaned, coated and partially populated with parts.

Once all components were off, the chassis and the two associated brackets were cleaned with an SOS pad and sanded to remove as much of the pitted corrosion as possible. When it was finally looking reasonably smooth it was coated with Rust-oleum Satin Nickel Metal and allowed to cure. The chassis with one of the brackets attached, along with the major components is shown in **Fig-**

**ure 6.** Be sure all lock washers are present during reassembly and all hardware is tight to assure good grounding. No problems were encountered in area, though all grounds were checked with an ohmmeter.

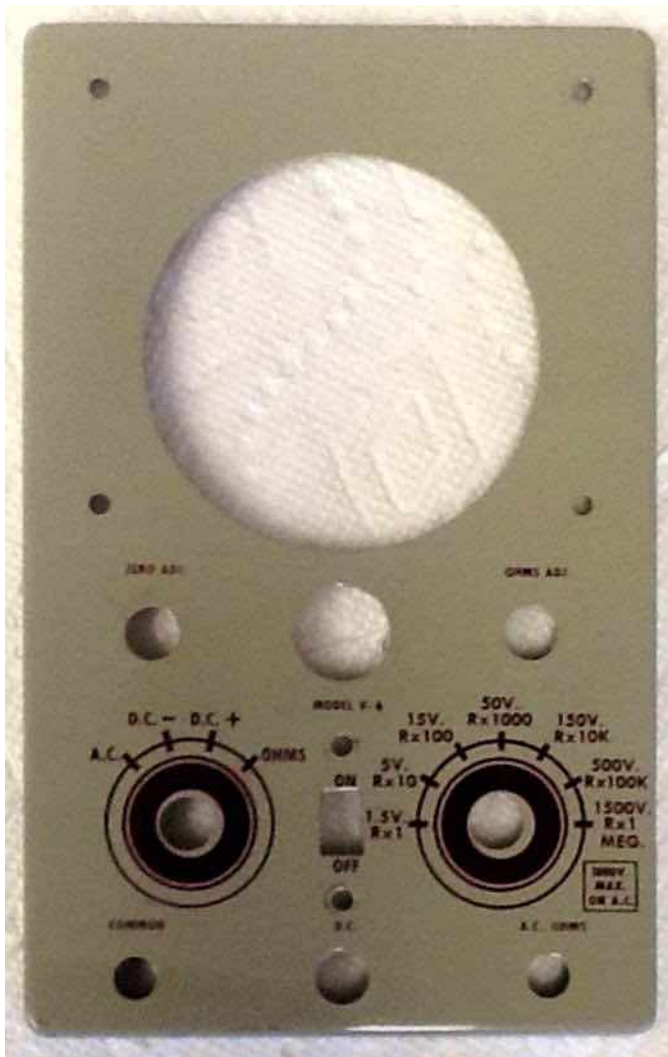
**Figure 7:** The front panel cleaned up nicely with just some Dawn detergent and warm water.

The front panel can be difficult to restore if scratched excessively, chipped or stained. Luckily the V-6 front panel cleaned up with just Dawn and warm water. The few minor scratches were allowed to remain “to add character”. **Figure 6** shows the front panel drying and **Figure 7** shows the back with some components installed.

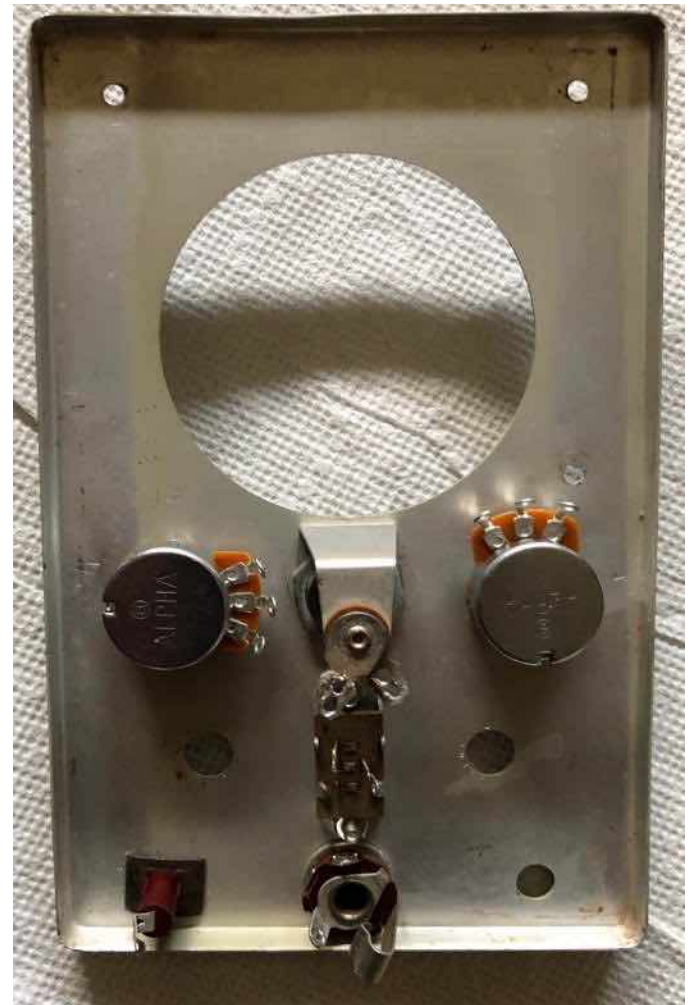
**Figure 8:** The front panel rear with **ZERO ADJ.** and **OHMS ADJ.** controls, pilot lamp, D.C. jack A.C. - OHMS jack and **OFF - ON** switch installed.

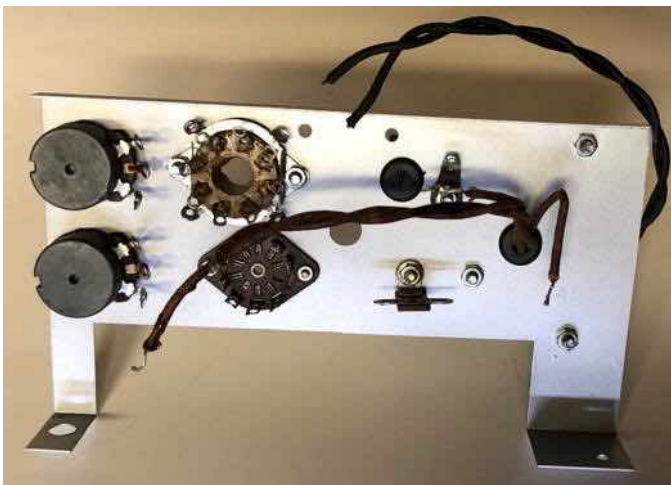
**Figure 9:** The underside of the chassis prior to wiring. The adjustment pots and tube sockets are original but cleaned and tested. The vacant hole is for the 7.5 MΩ pot.

Construction of the V-6 takes place in three parts. First the chassis is wired, then the front panel is wired, and finally the two are wired together. **Figure 9** shows the chassis underside prior to wiring. **Figure 10** shows the wired front panel prior to it being joined to the chassis and **Figures 11, 12 and 13** show the completed V-6 prior to being installed in the cabinet.

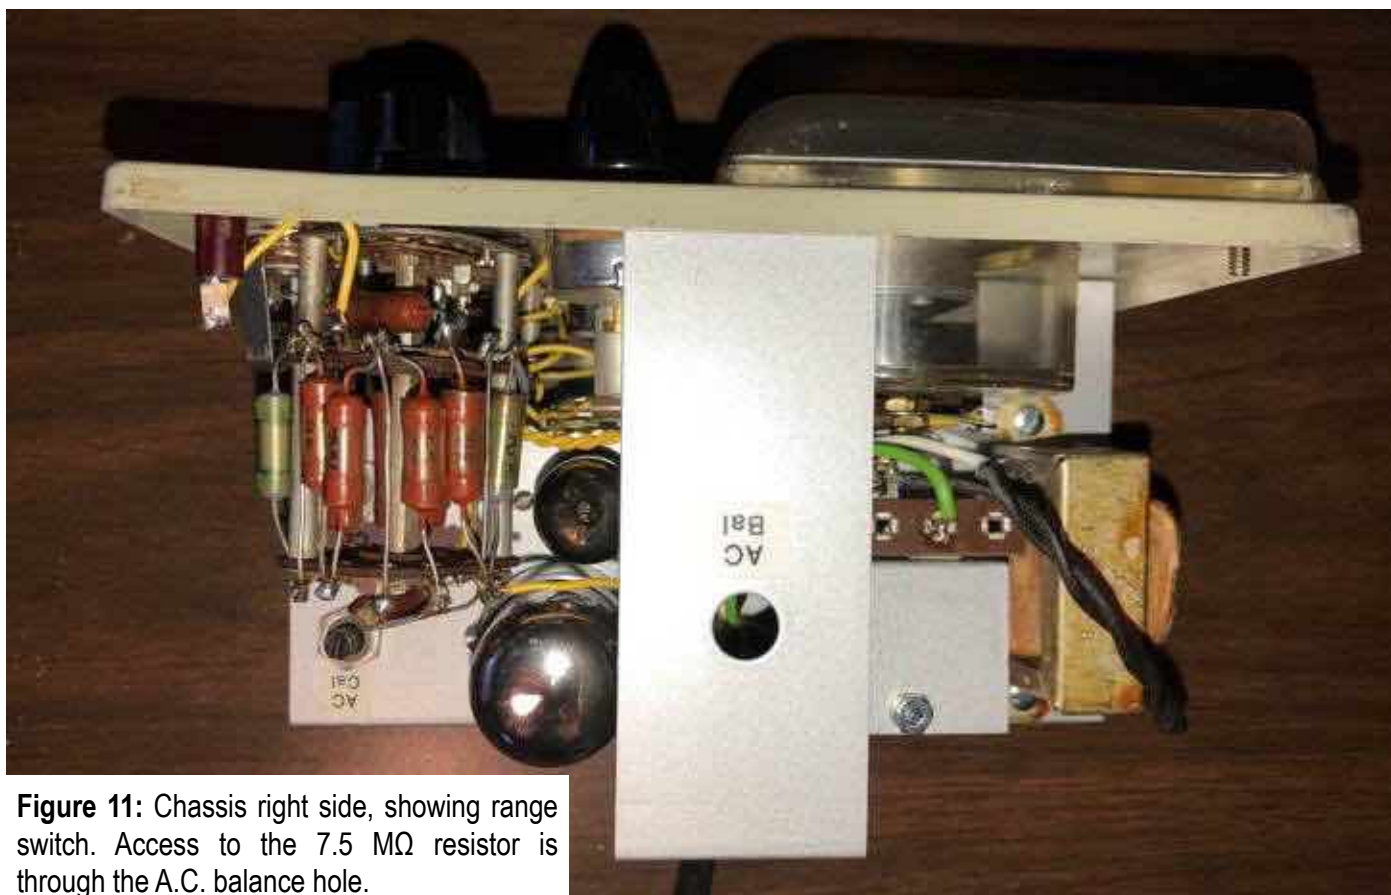
**Figure 11:** Chassis right side, showing range switch. Access to the 7.5 MΩ resistor is through the A.C. balance hole.

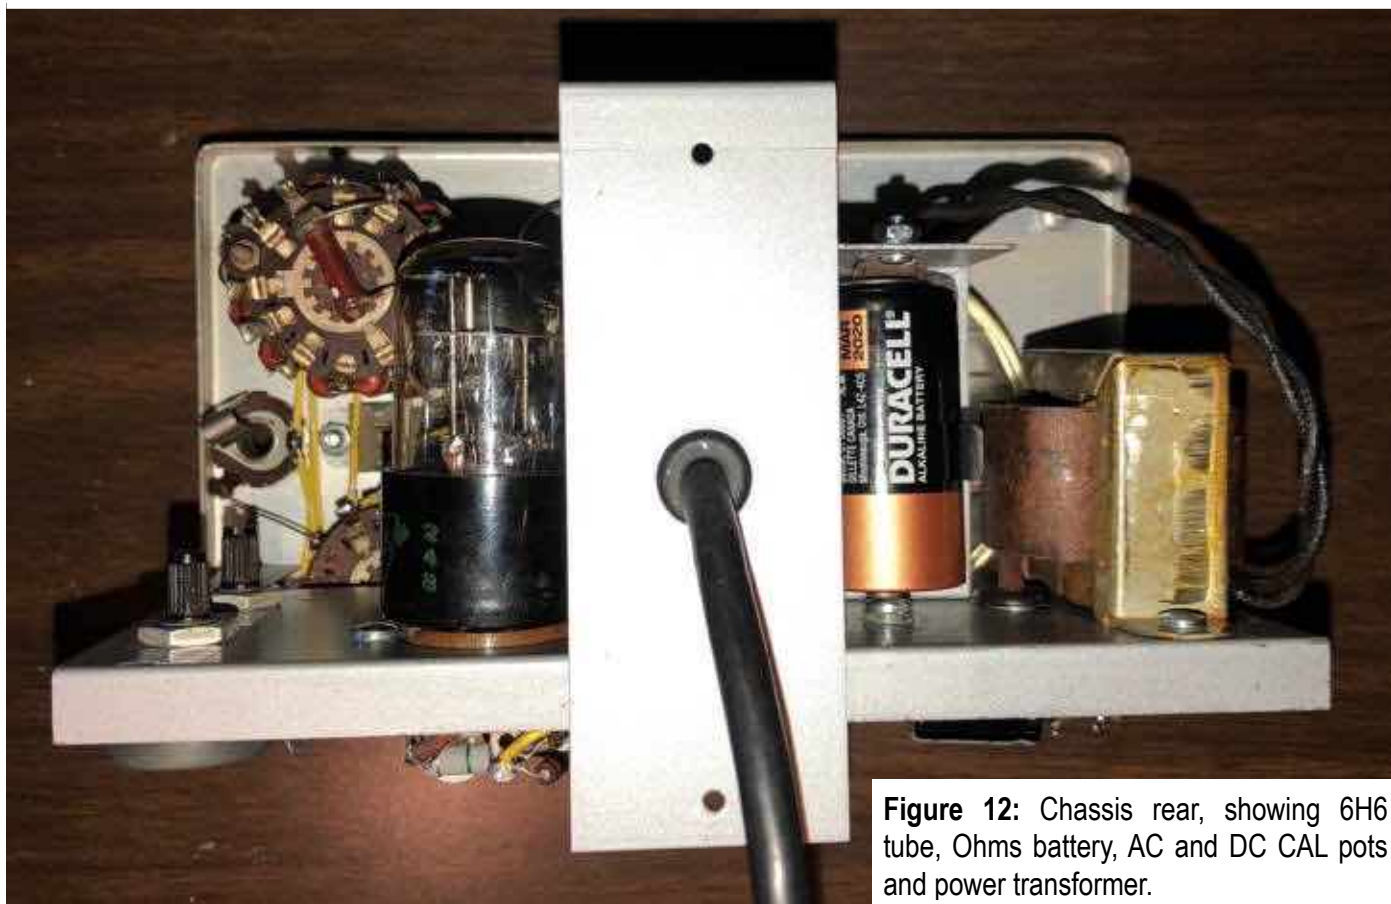
**Figure 12:** Chassis rear, showing 6H6 tube, Ohms battery, AC and DC CAL pots and power transformer.

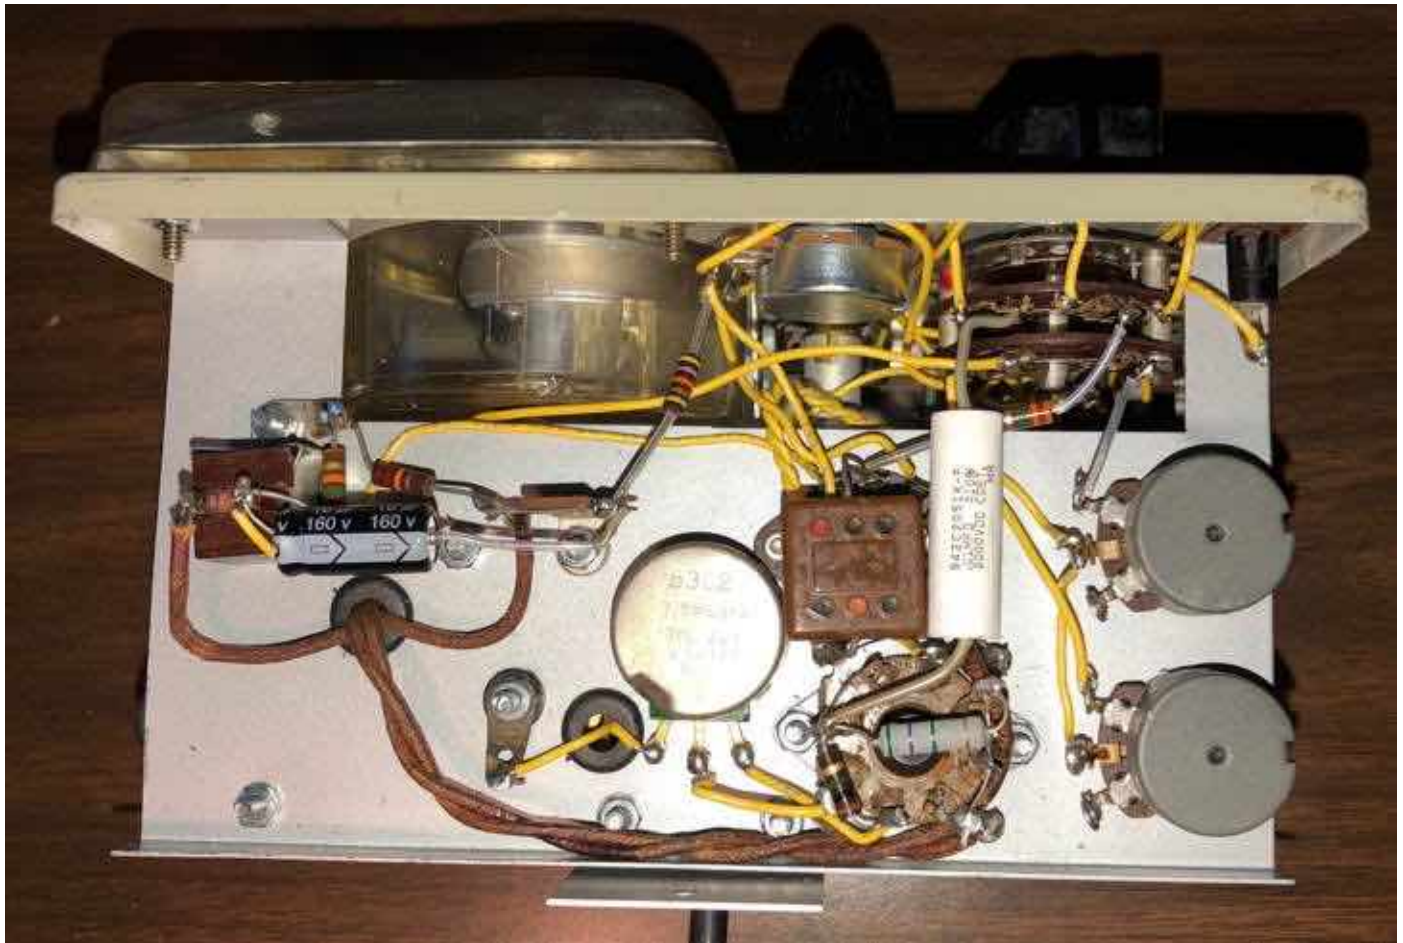
**Figure 13:** Chassis left side, showing "siliconized" selenium rectifier (left), 7.5 M  $\Omega$  potentiometer (lower center), old style mica capacitor and new 0.01 2,000V capacitor (above octal tube socket), and function switch (in cutout, to right).

One chronic problem Heathkit VTVMs suffered is poor AC balance. When switching from one of the DC positions to AC the meter zero would change; this is caused by the contact potential generated by each section of the duo-diode tube. The V-1 and V-2 did not have any adjustment to correct this. When the V-4 came out (the V-3 was a different beast) it sported an **A.C. Balance** adjustment pot. This pot used the contact potential in one diode section to cancel out the contact potential in the second section, however this only works if the correct tube section has the higher contact potential. Heath probably preselected the tubes for the V-4, but this meant about half their 6H6 tube inventory could not be used in the V-4. Heath fought the AC balance problem from the V1 up to the V7. Each had a different AC rectification circuit, and at one time Heath even changed the tube to a loctal 7A6. In the V-7 Heath solved the problem by tapping off voltage from the B+ supply using a variable resistor, and coupling it to the duo-diode tube through a string of five 22 MΩ resistors. This circuit worked extremely well and has not been
